PHASE IV REPORT

VOLUME II

RESULTS AND INTERPRETATION OF CHEMICAL GROUTING TEST PROGRAM

EXISTING LOCKS AND DAM NO. 26
MISSISSIPPI RIVER, ALTON, ILLINOIS

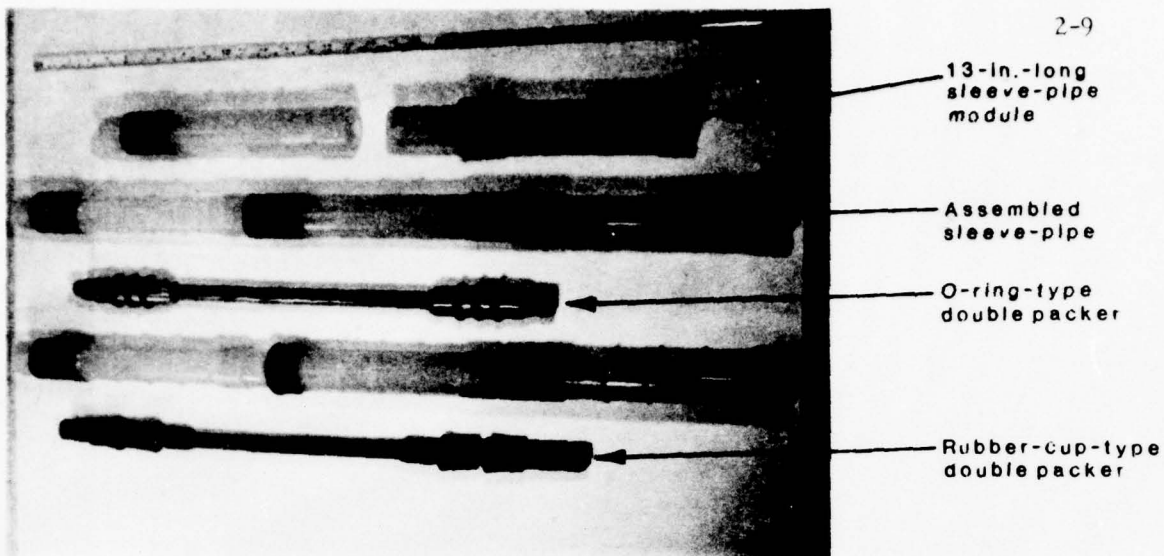
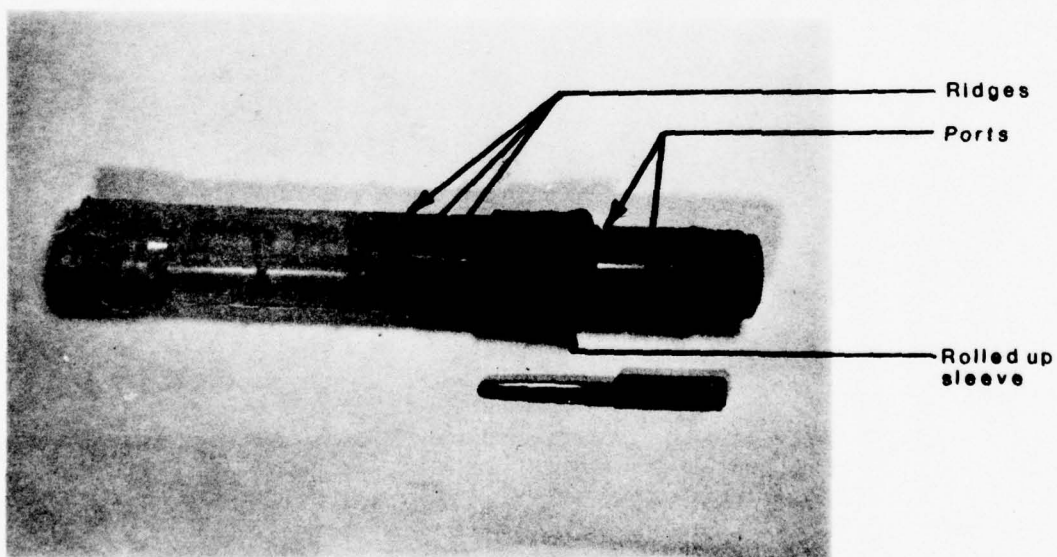
Fig. 2.1

The chemical grouting tests were conducted in an area immediately adjacent to US Route 67, downstream of the left abutment of the dam, on the Missouri side of the Mississippi River; see Fig. 2.4. At that location, the natural ground surface was at approximately el 420. The test area was filled and graded at el 423. An 8-in.-thick asphalt grouting pad, 70 ft by 67 ft, was constructed at el 423 at the center of the test area to serve as a working surface. The grout holes, installed from the asphalt pad, were arranged to form fourteen test subareas as shown in Fig. 2.1. The test variables corresponding to each subarea are given in Table 2.1.

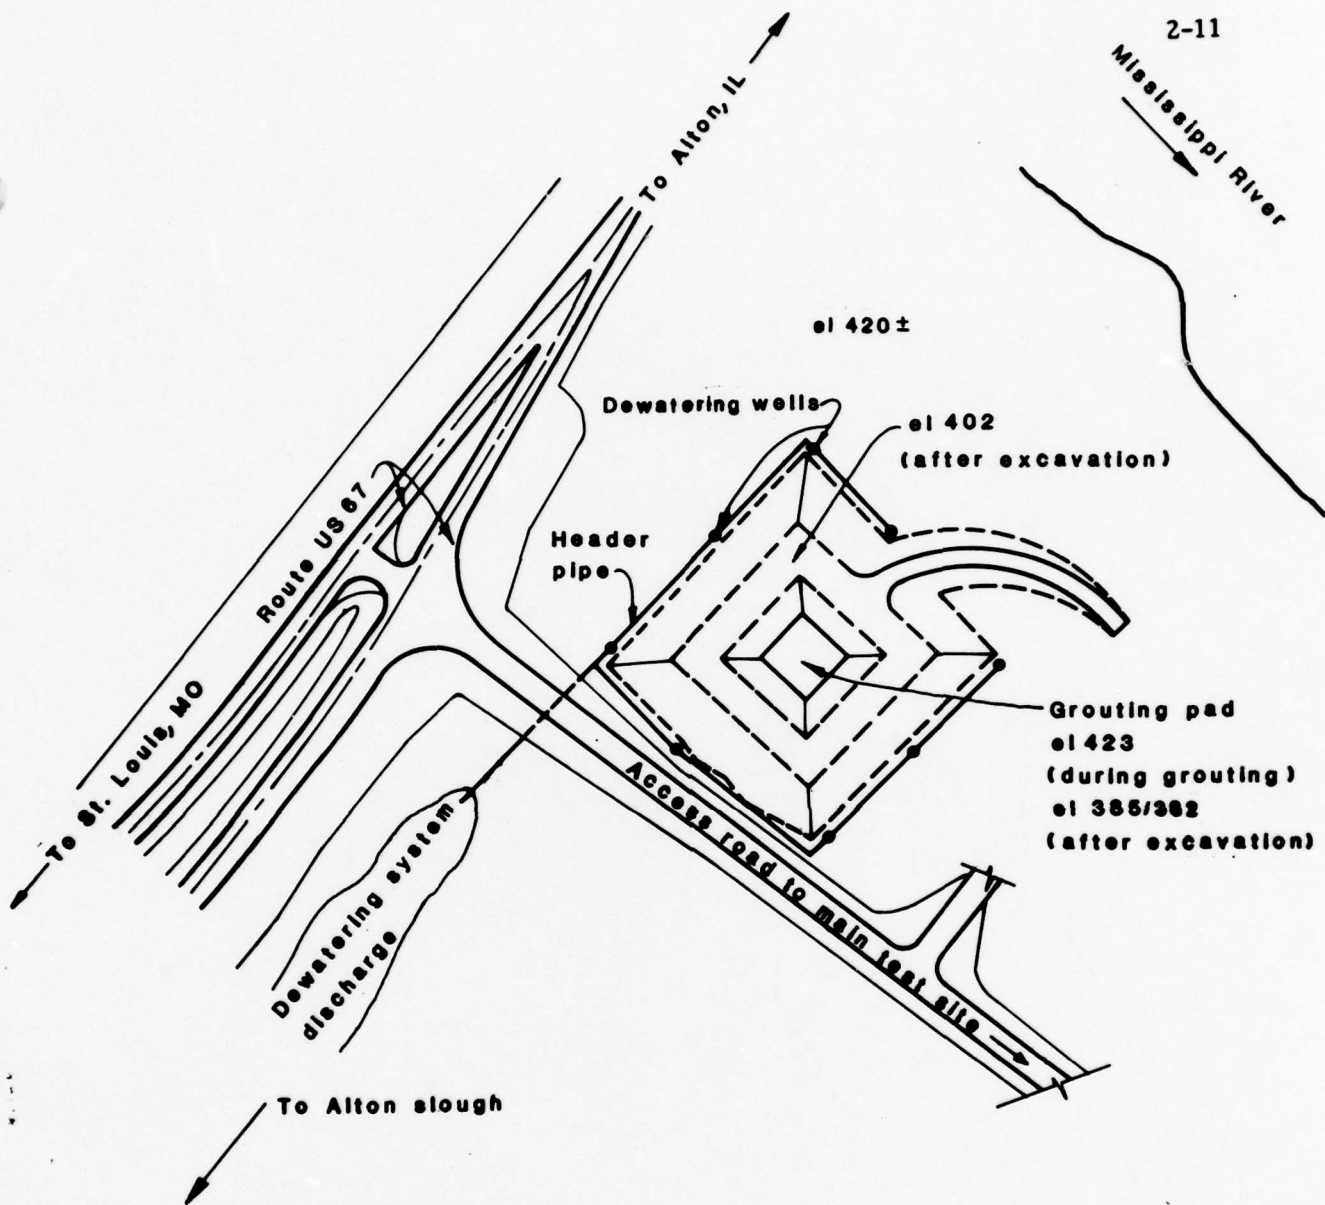
Fig.2.3

CHEMICAL GROUTING TEST PROGRAM	
TEST AREA CONFIGURATION	
FOUNDATION INVESTIGATION AND TEST PROGRAM EXISTING LOCKS AND DAM No. 28 ST LOUIS DISTRICT, CORPS OF ENGINEERS. DACW43-78-C-0008

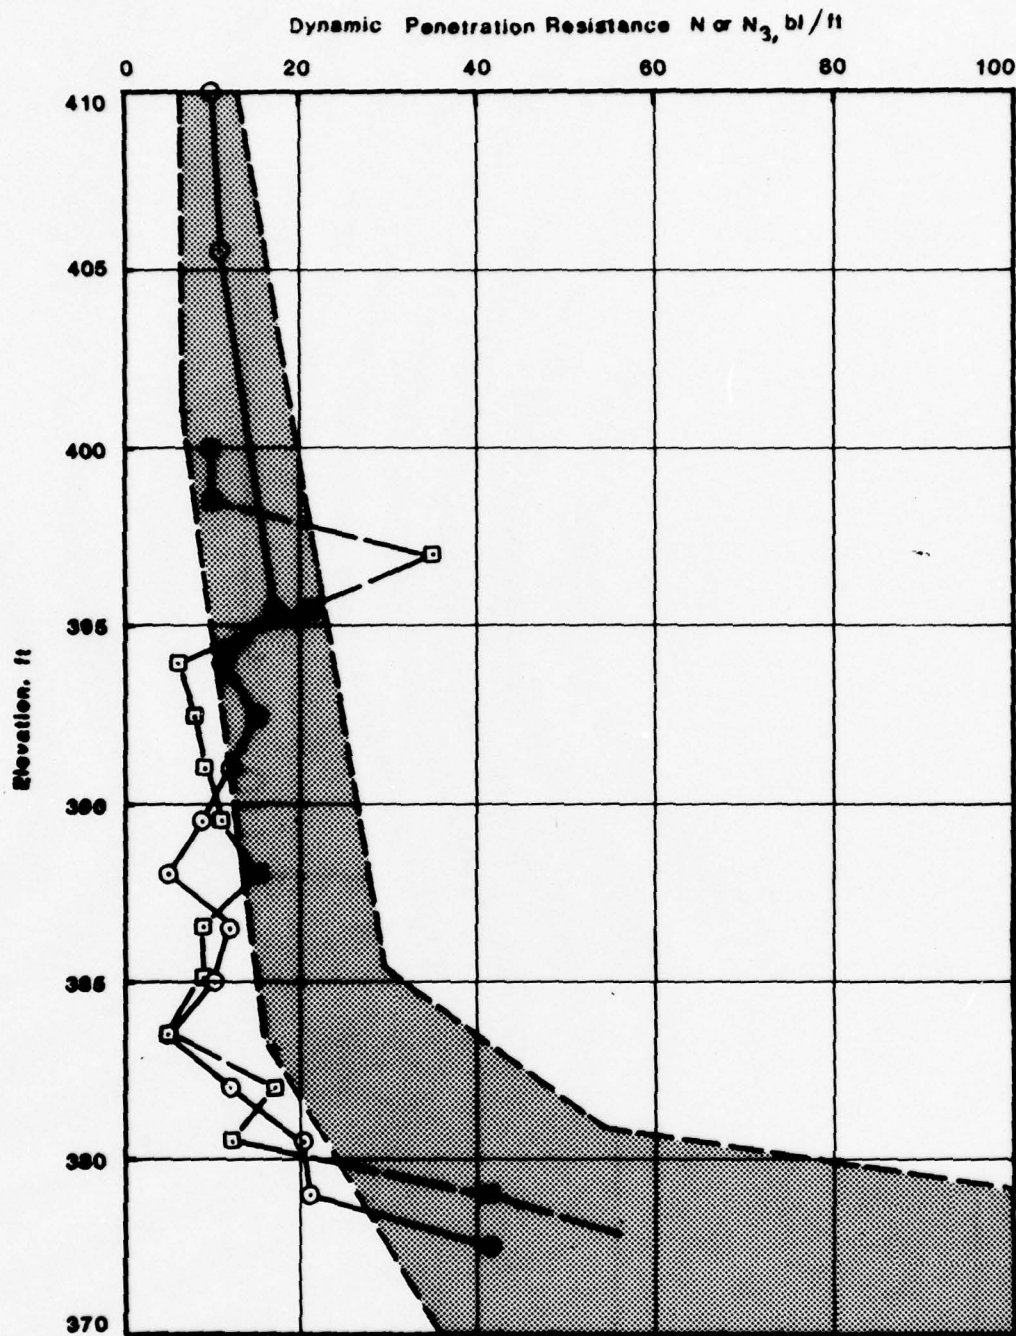
Fig. 3.2

- Range of standard penetration resistance N
- N_3 measured in D-25
- N_3 measured in BM-1

The results of the two static cone penetration soundings made before grouting are shown in Fig. 3.2, together with other in situ test results. The correlation between cone penetration resistance q_c and standard penetration resistance N measured in the test area is presented in Fig. 3.4. This correlation is approximated by:

Falling head permeability tests were performed in Boring D-28. The tests were conducted by driving an NX-size, flush-joint casing into the soil to the desired testing depths, cleaning out the soil with a rotary drill bit and circulating water, and flushing the casing with clean water to remove bottom sediment. The casing was filled with water and the elevation of the water surface in the casing was measured as a function of time. The coefficients of permeability obtained from these tests are given in Fig. 3.2, together with other in situ test results.

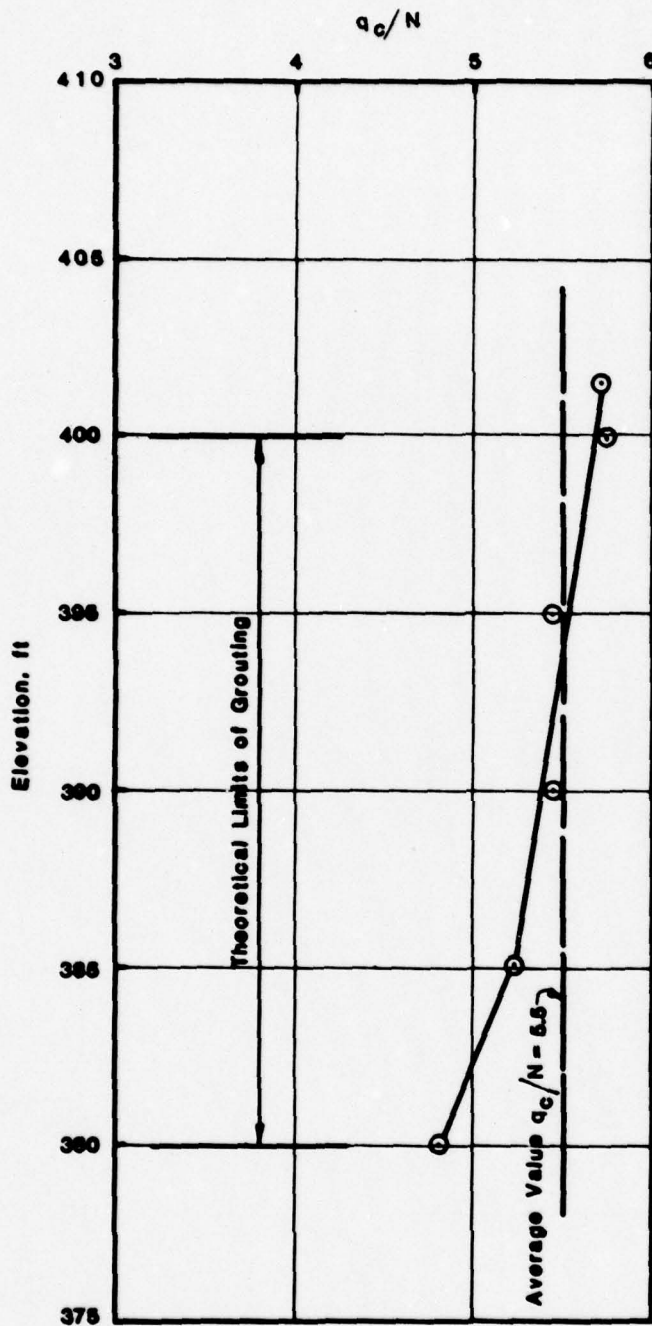
Fig. 3.3

**CHEMICAL GROUTING TEST PROGRAM
CORRELATION
BETWEEN STANDARD
AND STATIC CONE PENETRATION
RESISTANCE BEFORE GROUTING**

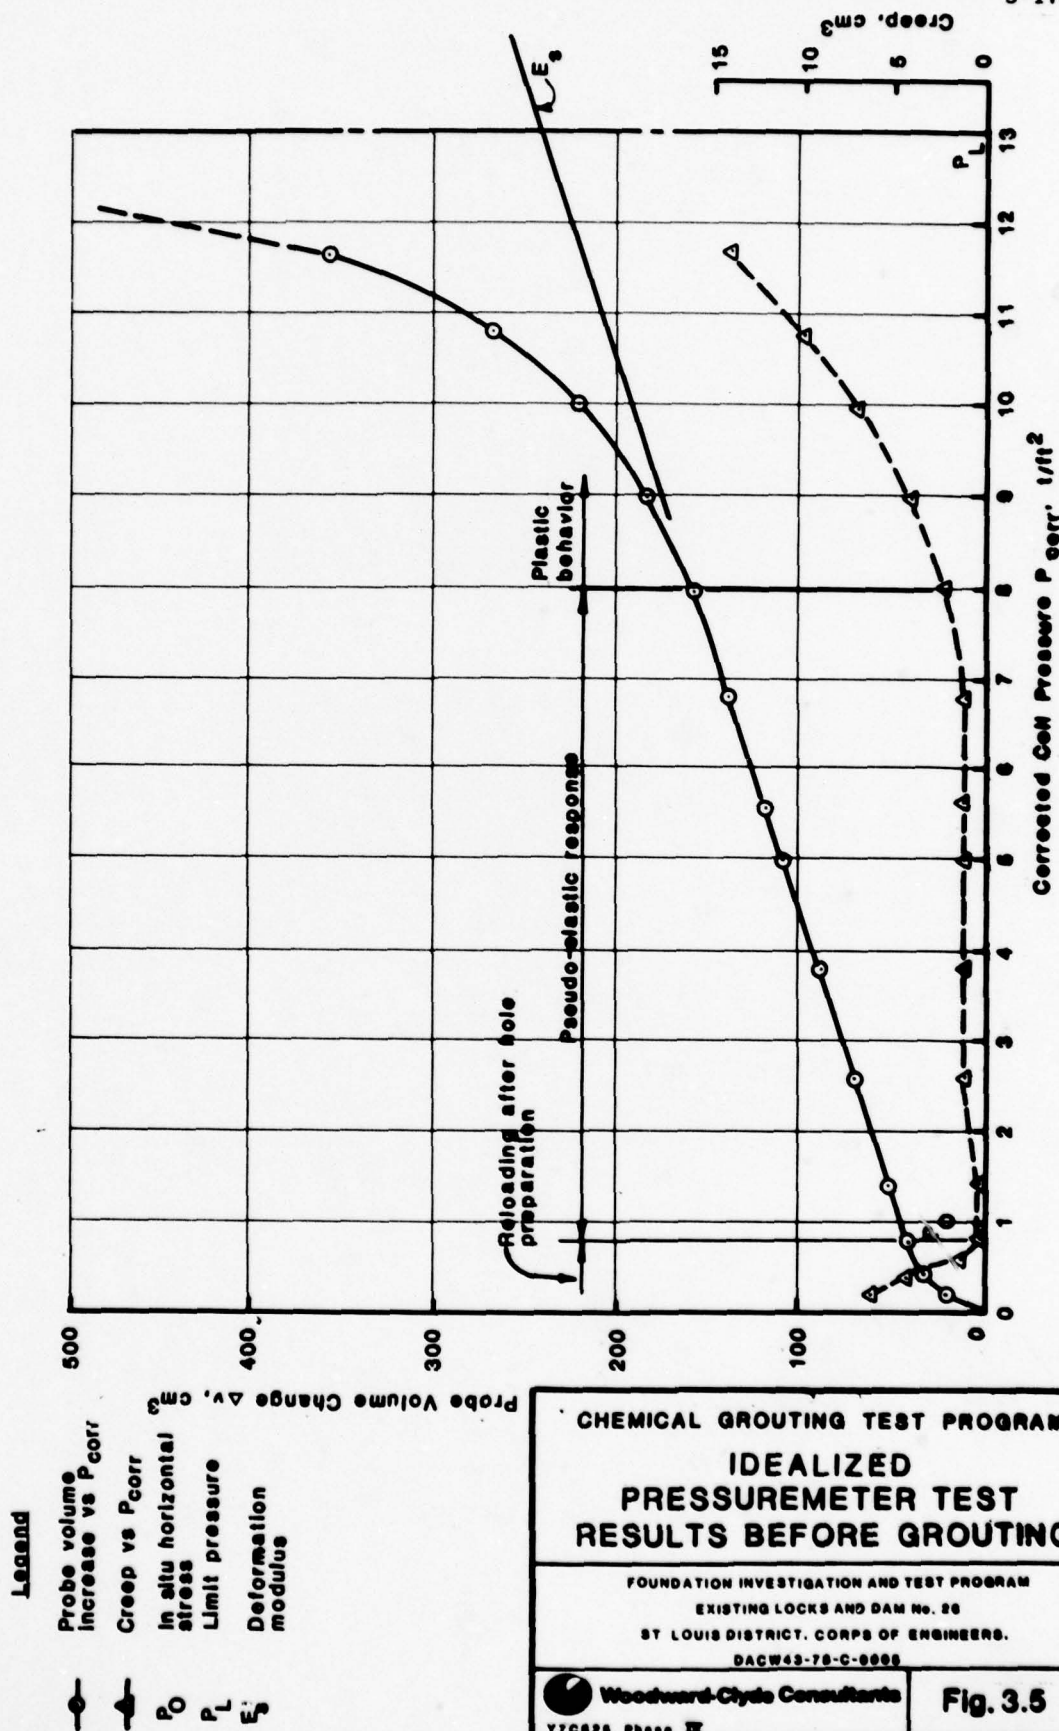
Fig. 3.4

CHEMICAL GROUTING TEST PROGRAM
IDEALIZED
PRESSUREMETER TEST
RESULTS BEFORE GROUTING

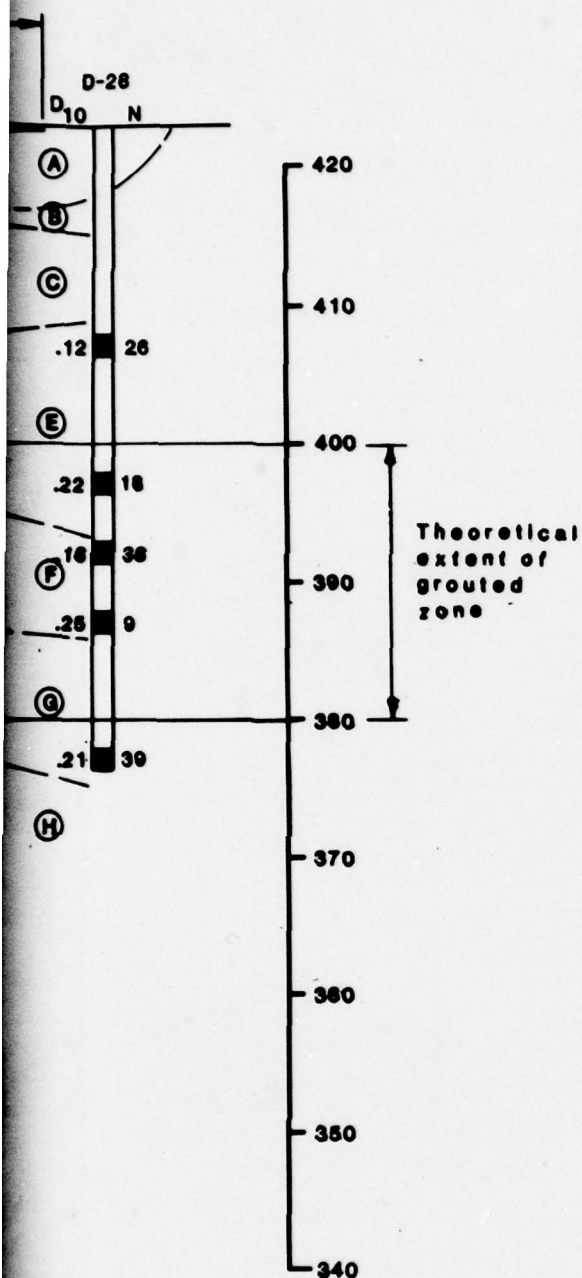
CHEMICAL GROUTING TEST PROGRAM	
SUBSURFACE PROFILE C-C OF TEST AREA	
FOUNDATION INVESTIGATION AND TEST PROGRAM EXISTING LOCKS AND DAM No. 26 ST. LOUIS DISTRICT, CORPS OF ENGINEERS. DACW43-78-C-0008	
Woodward-Clyde Consultants V7C825 Phase III	Fig. 3.8

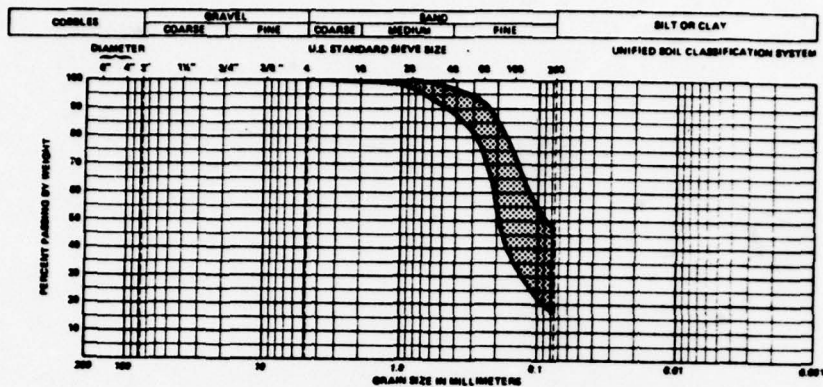
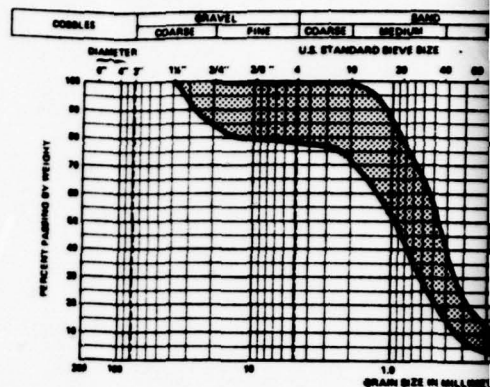
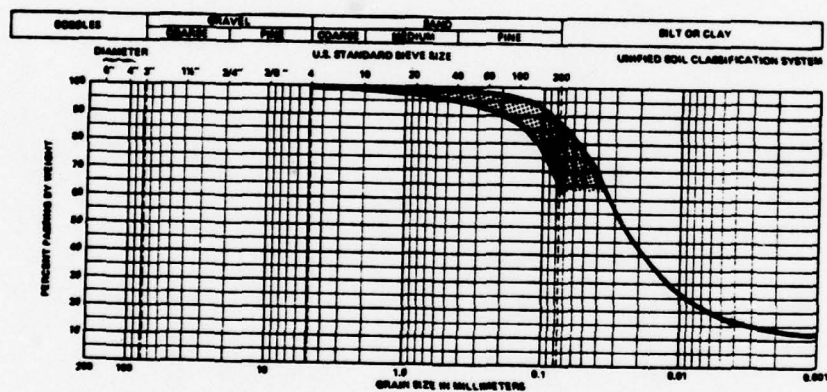
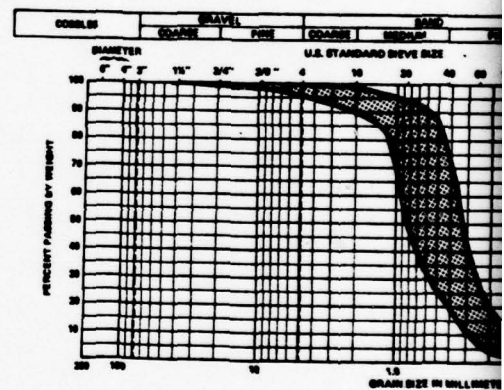
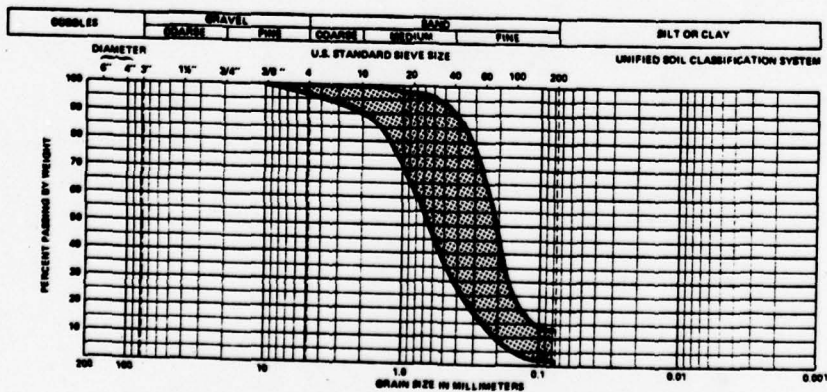
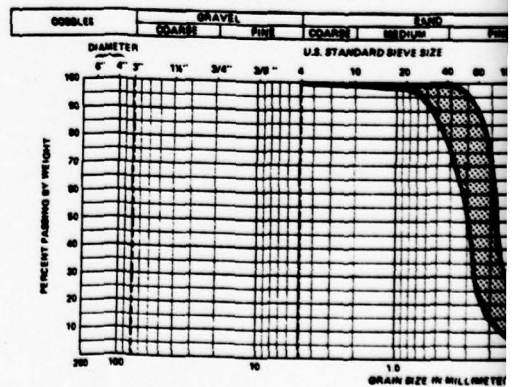
Stratigraphic Unit C

Stratigraphic Unit D

Stratigraphic Unit E

Stratigraphic Unit F

Stratigraphic Unit G

Stratigraphic Unit H

Laboratory grain-size analyses performed on samples obtained from borehole sampling and excavation mapping were significant in differentiating stratigraphic units. The ranges of grain-size distribution for units C through H are given in Fig. 3.9.

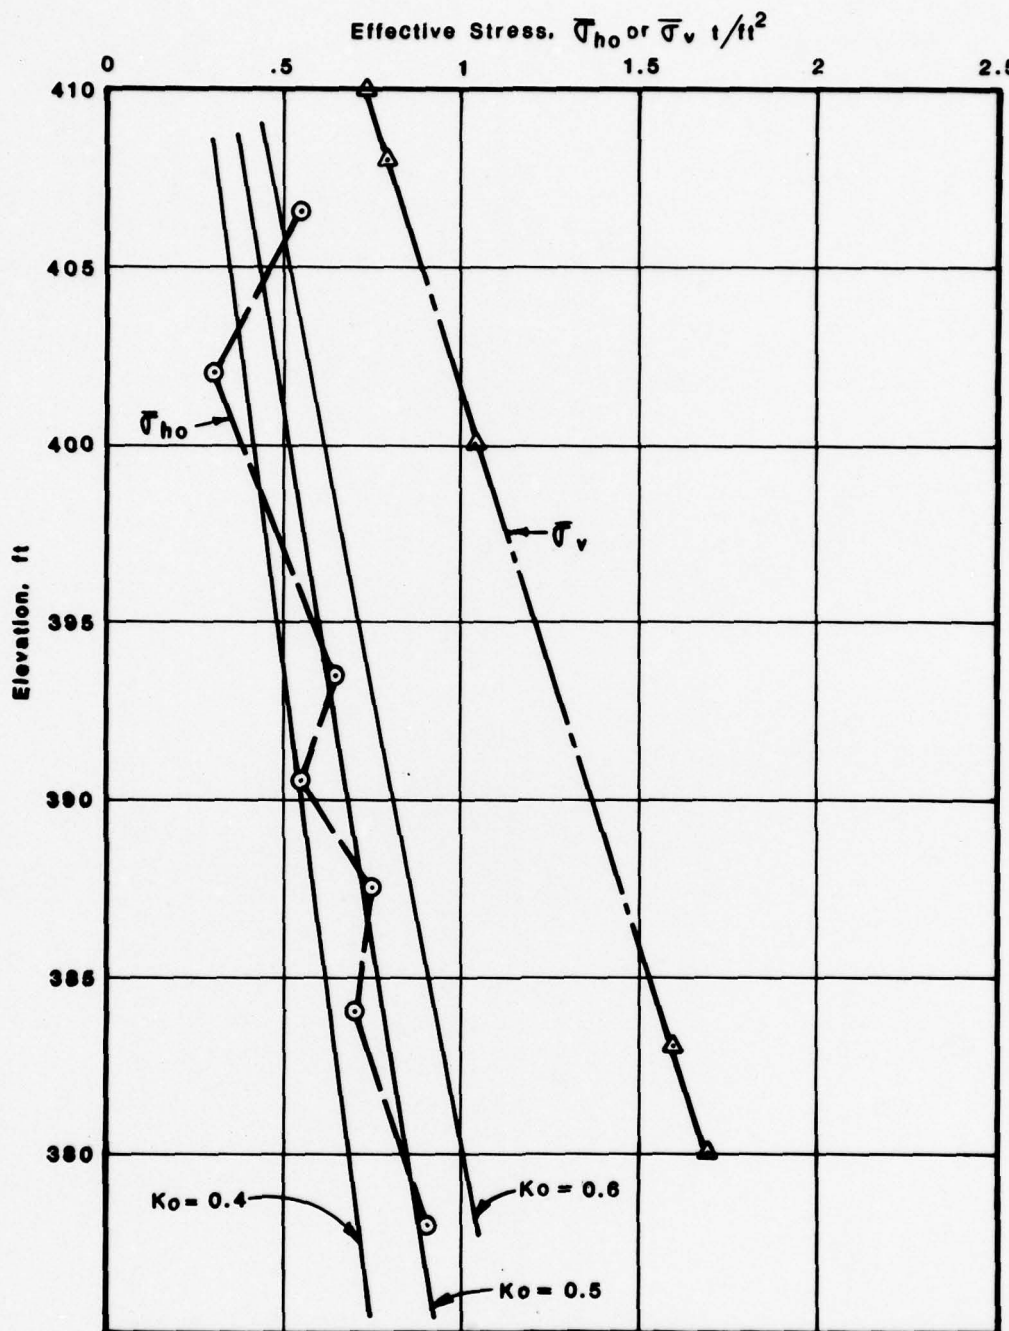
Fig. 3.9

- △— Effective vertical stress $\bar{\sigma}_v$
- Effective horizontal stress $\bar{\sigma}_{ho}$
- $K_o = \frac{\bar{\sigma}_{ho}}{\bar{\sigma}_v}$

The in situ state of stress was evaluated from pressuremeter and density tests results, and field observations. The vertical effective stress profile calculated from estimated unit weights is shown in Fig. 3.10. The horizontal total stress was measured during pressuremeter testing as the cell pressure at which the undisturbed elastic resistance of the soil was mobilized, that is, the stress at which the pressure-volume change curve becomes linear. The horizontal effective stress was obtained by subtracting the static pore pressure because the tests are assumed to be fully drained. The inferred horizontal effective stress profile before grouting is shown in Fig. 3.10. The coefficient of lateral earth pressure at rest K_0 is the ratio of horizontal to vertical effective stress. For the test area, before grouting, K_0 ranged from 0.4 to 0.6 and averaged 0.48, indicative of normally consolidated sand.

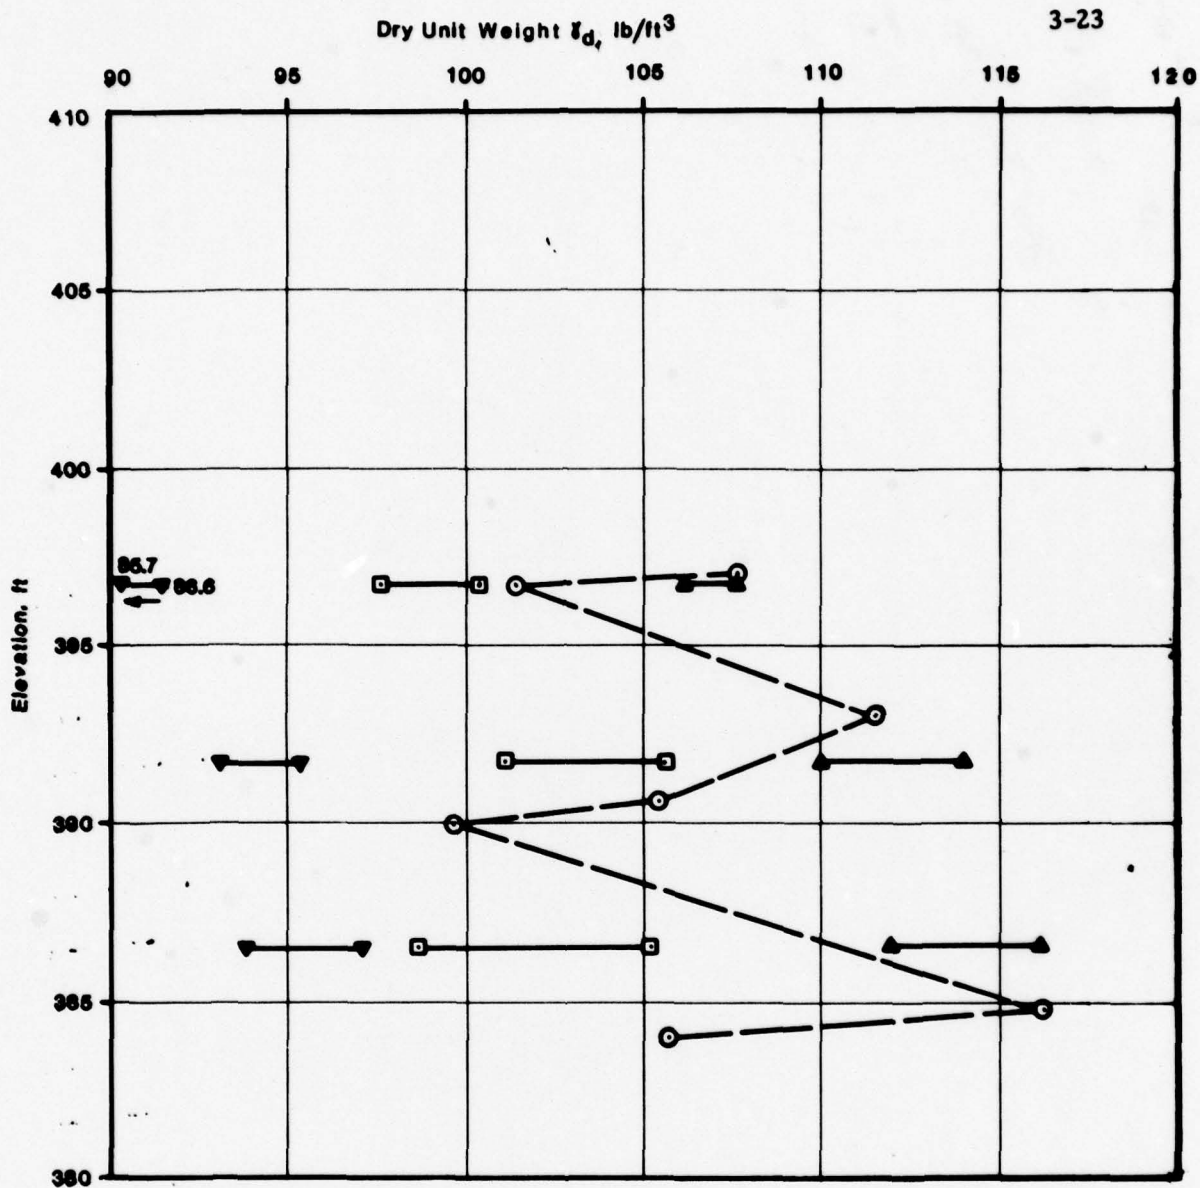
Fig. 3.10

- In-place dry unit weight from excavation
- Lab dry unit weight
- ▼— Minimum dry unit weight
- ▲— Maximum dry unit weight

Total and dry unit weights were determined from Phase II laboratory testing of undisturbed samples and from in-place density tests of ungrouted soil made during excavation of the test area (Section 9.3). Maximum and minimum dry unit weights were determined in the laboratory from undisturbed samples taken during Phase II investigations. These results were supported by Proctor and Providence testing of borehole samples reconstituted in the laboratory in preparation for the laboratory grouting program (Section 5.1). In-place unit weights are plotted vs maximum and minimum unit weights from Phase II studies in Fig. 3.11.

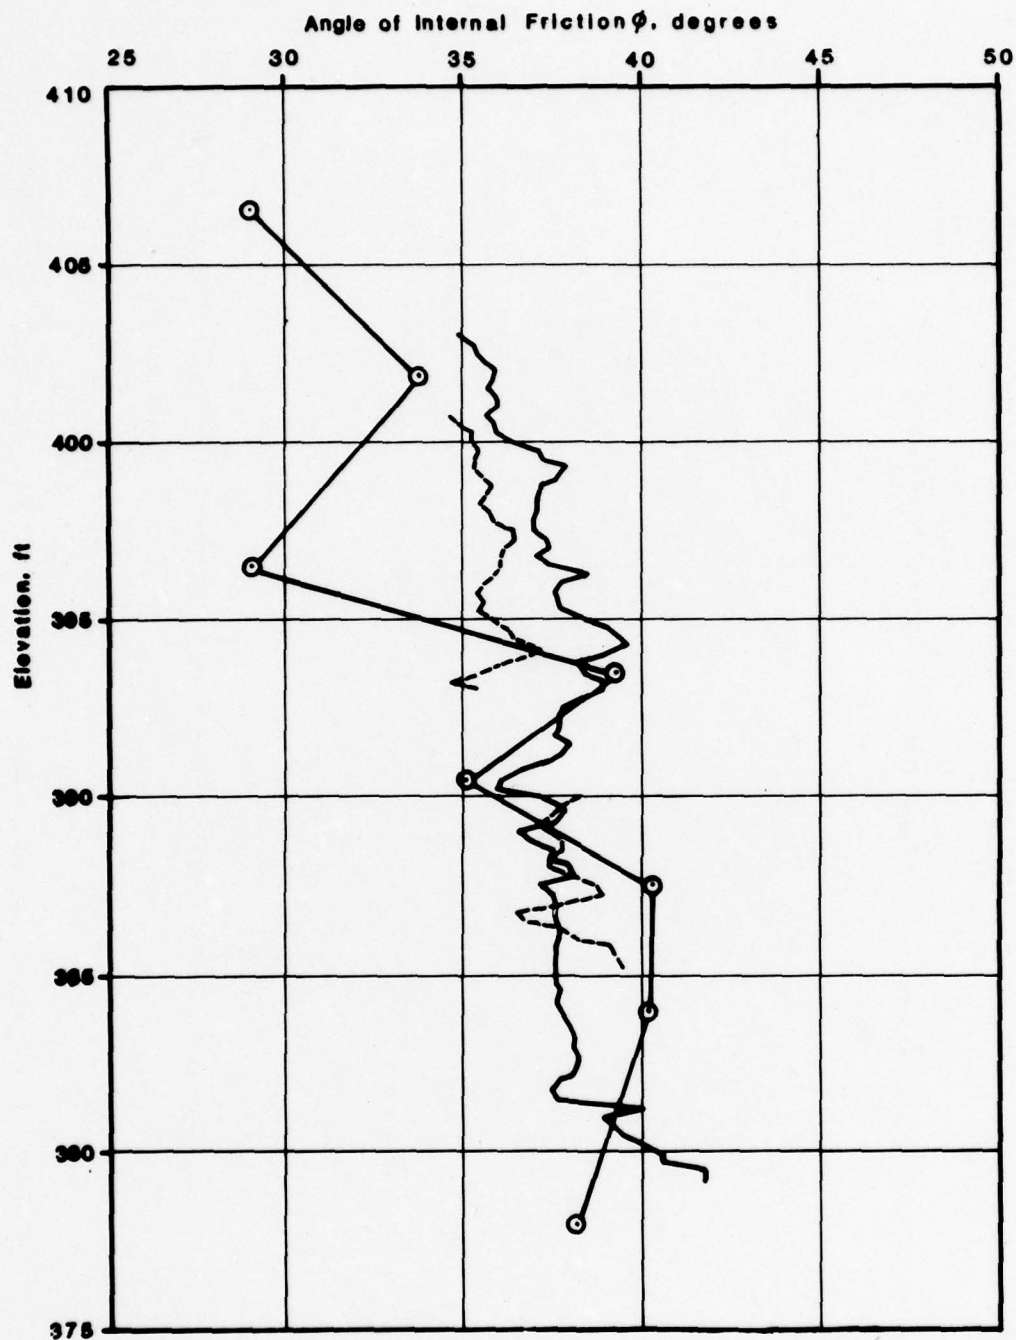
Fig. 3.13

- - - - Boring D-23 } From static cone
 penetration point
 resistance using
 Meyerhof (1974)
 correlation
 ——— Boring D-26 }
 —○— Boring D-27 From
 pressuremeter tests using
 Hughes, Wroth & Windle
 (1977) approach

Modulus values calculated from pressuremeter tests in Boring D-27 are presented in Fig. 3.13.

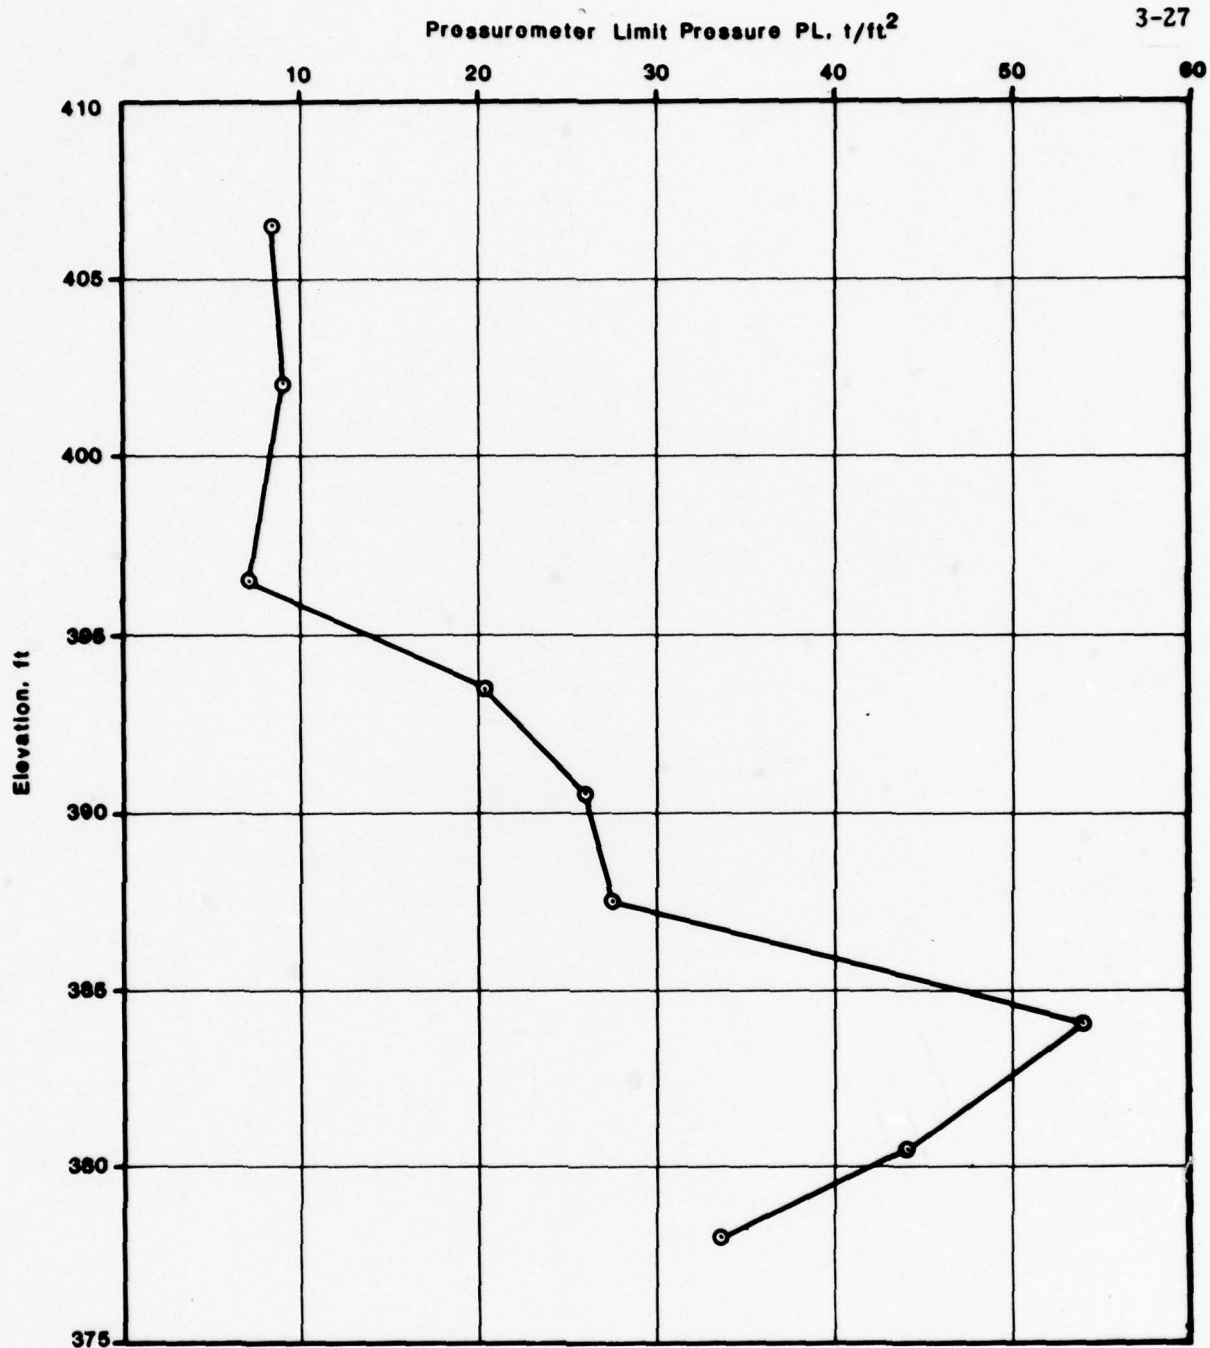
Fig. 3.14

PRESSUREMETER
LIMIT PRESSURE PROFILE
BEFORE GROUTING

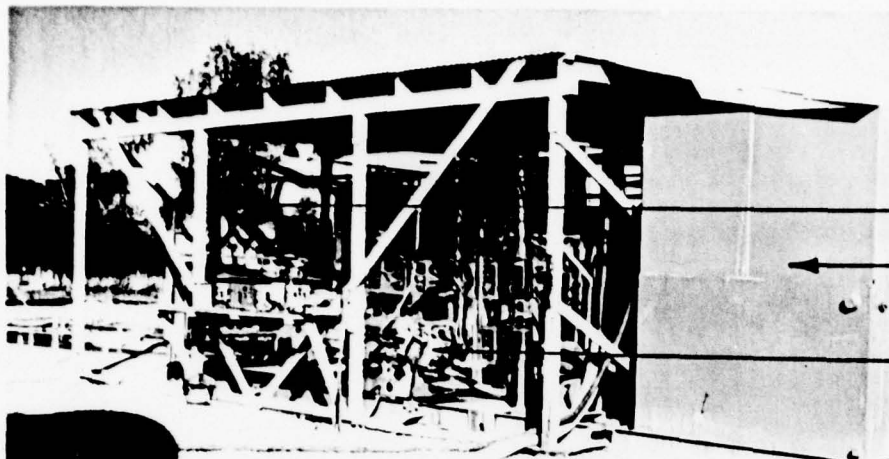
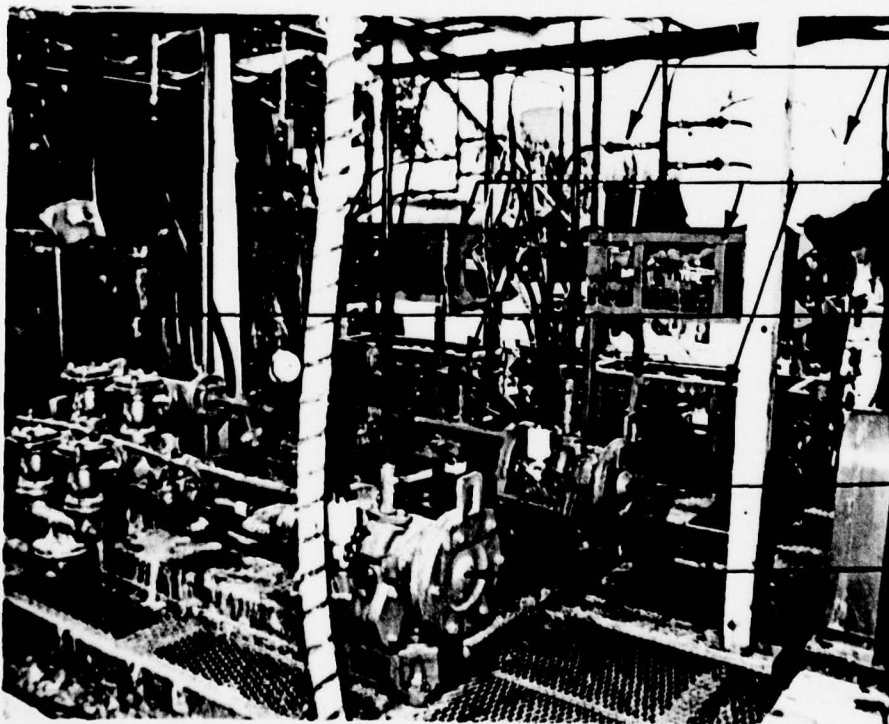
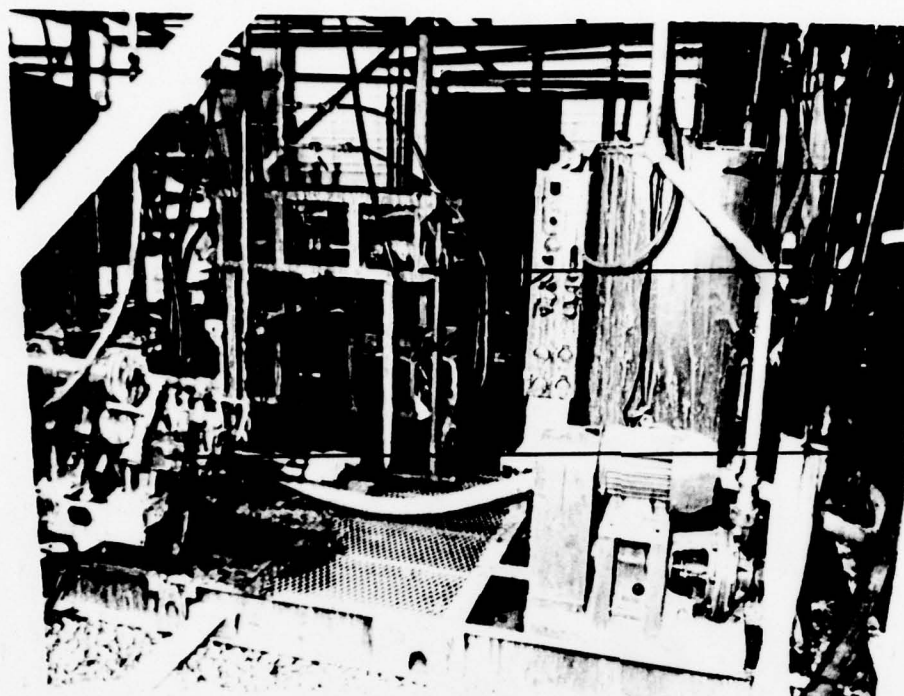
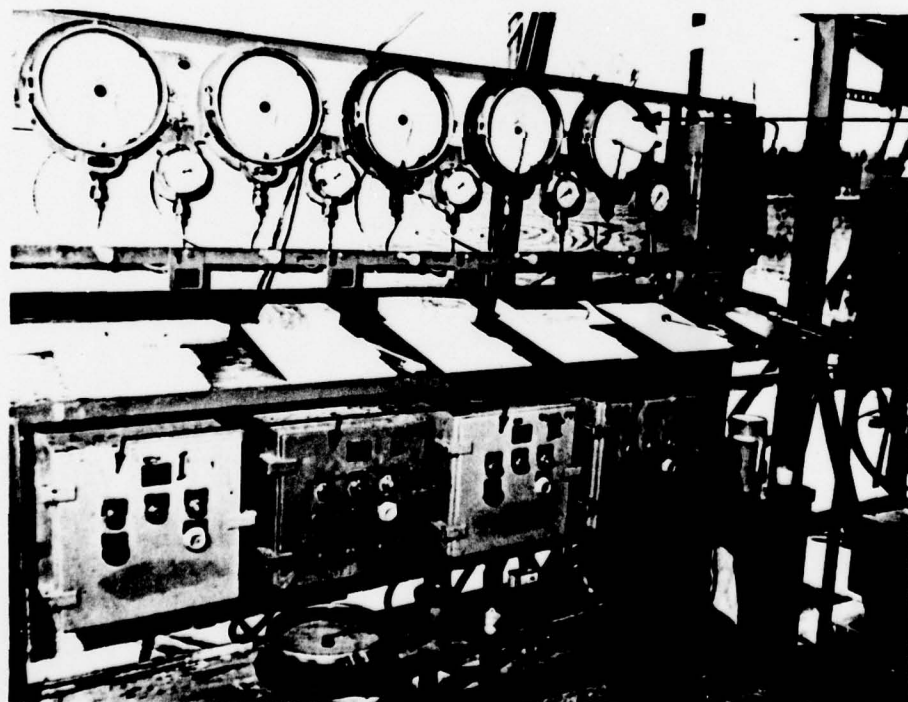
Control panel

Tanks
11,12,13,14

Module 2

Components
Storage

Grout counters
25,26,27,28

Mother Unit 24

Grout Counters
25,27

Grout pump 22

Pressure
recorders

Pressure
gages

All electrical, mechanical and pneumatic equipment required for storing and diluting grout components; proportioning, mixing, metering, and pumping grout; and monitoring grout pumping pressure and flow rate were assembled in a modular grouting plant. The plant consisted of four modules, compact enough to be transportable by truck. Each module could perform independent grouting tasks, or could be combined with one or more other modules to form units of larger capacity. Photographs of the grouting plant are shown in Fig. 4.1 and 4.2.

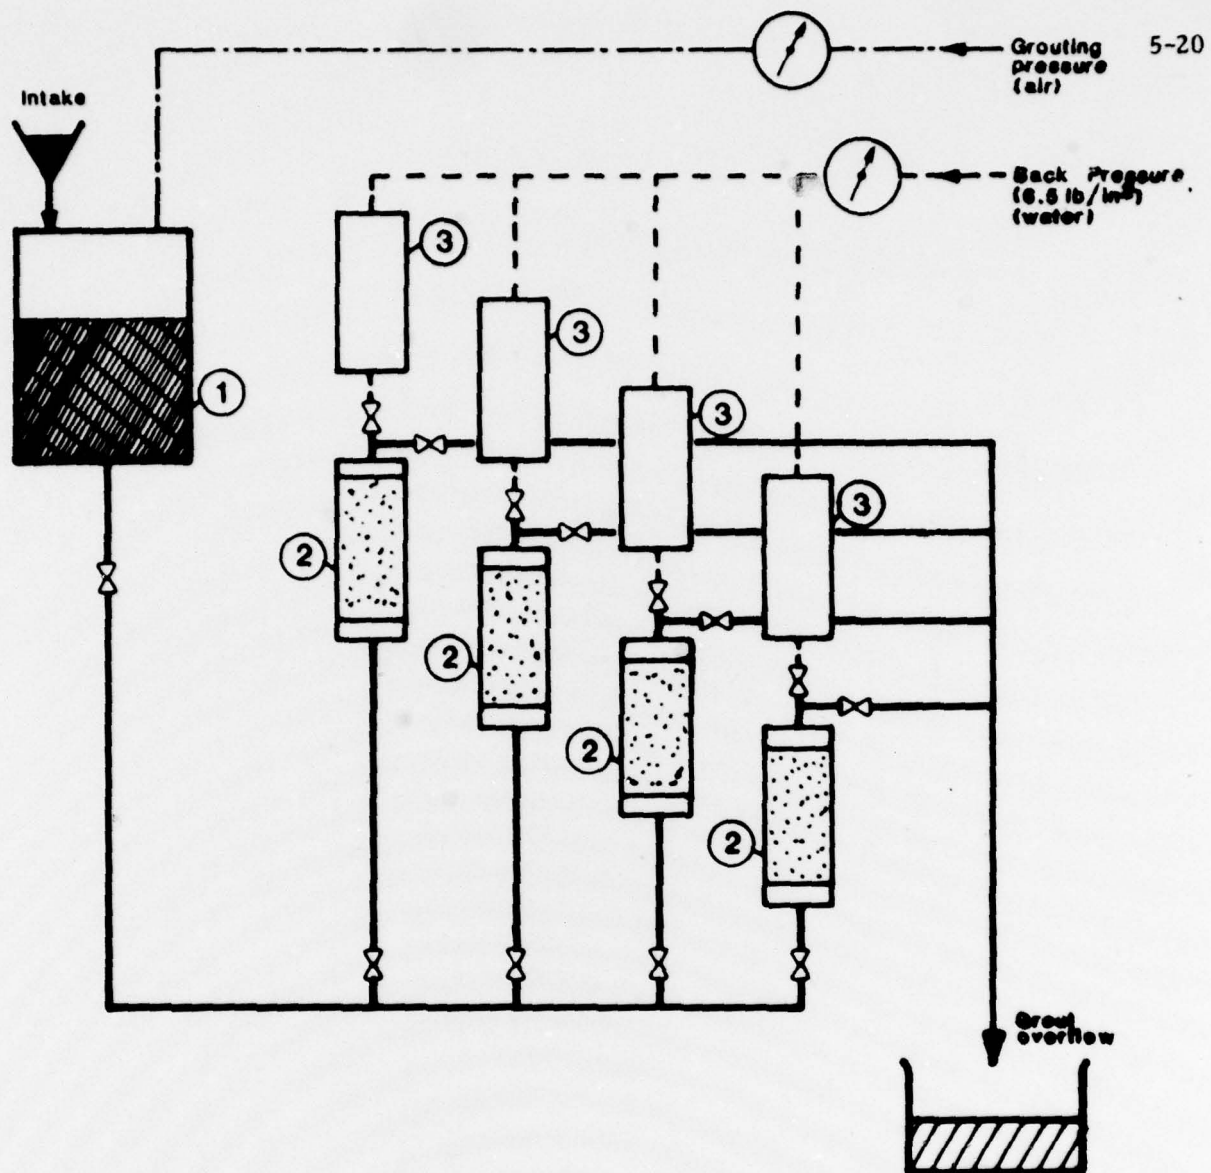
Fig 5.1

- ① Grouting tank assembly (Mixing, agitating, pressurizing)
- ② Sample reconstitution tubes
- ③ Saturating tanks
- — — — — Air line
- - - - - Water line
- Grout line

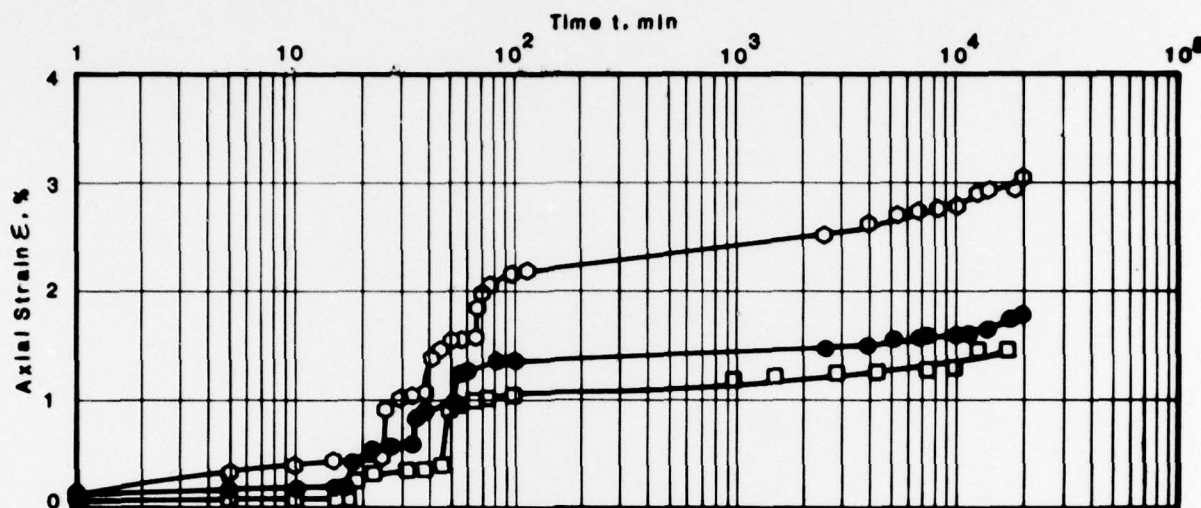
Fig 5.3

SYMBOL	TEST NO.	Time t , min									CONSTANT DEVIATOR STRESS APPLIED $(\sigma_1 - \sigma_3)$ t/ft^2	CONSTANT STRESS RATIO $(\sigma_1 - \sigma_3)/(\sigma_1 - \sigma_3)_{max}$
		0	17	24	33	34	40	48	52	65		
●	T-27	1.58 (0.15)	3.12 (0.29)	3.12 (0.29)	3.12 (0.29)	4.75 (0.45)	4.75 (0.45)	4.75 (0.45)	6.34 (0.59)	6.34 (0.59)	←	←
○	T-28	2.12 (0.20)	2.12 (0.20)	4.20 (0.39)	4.20 (0.39)	4.20 (0.39)	6.30 (0.59)	6.30 (0.59)	6.30 (0.59)	8.40 (0.79)	←	←
□	T-31	1.05 (0.10)	2.15 (0.20)	2.15 (0.20)	3.15 (0.30)	3.15 (0.30)	3.15 (0.30)	4.25 (0.40)	4.25 (0.40)	4.25 (0.40)	←	←

Unconfined Compression Tests. Results of long-term unconfined compression tests on reconstituted sand samples grouted in the laboratory are presented in Section 5.1.3 and Fig. 5.3. From these results, it appears that none of the tests approached failure or creep rupture. Creep rates, that is the ratio change in strain/change in time, were almost identical at CSR* of 50, 37 and 25 percent. At CSR of 15 percent, the creep rate is somewhat different, probably due to sample differences. Similar tests were performed by Clough et al (1979) and Koenzen (1978). Results of these tests are compared with Locks and Dam No. 26 test results in Fig. 9.48 and are summarized below.

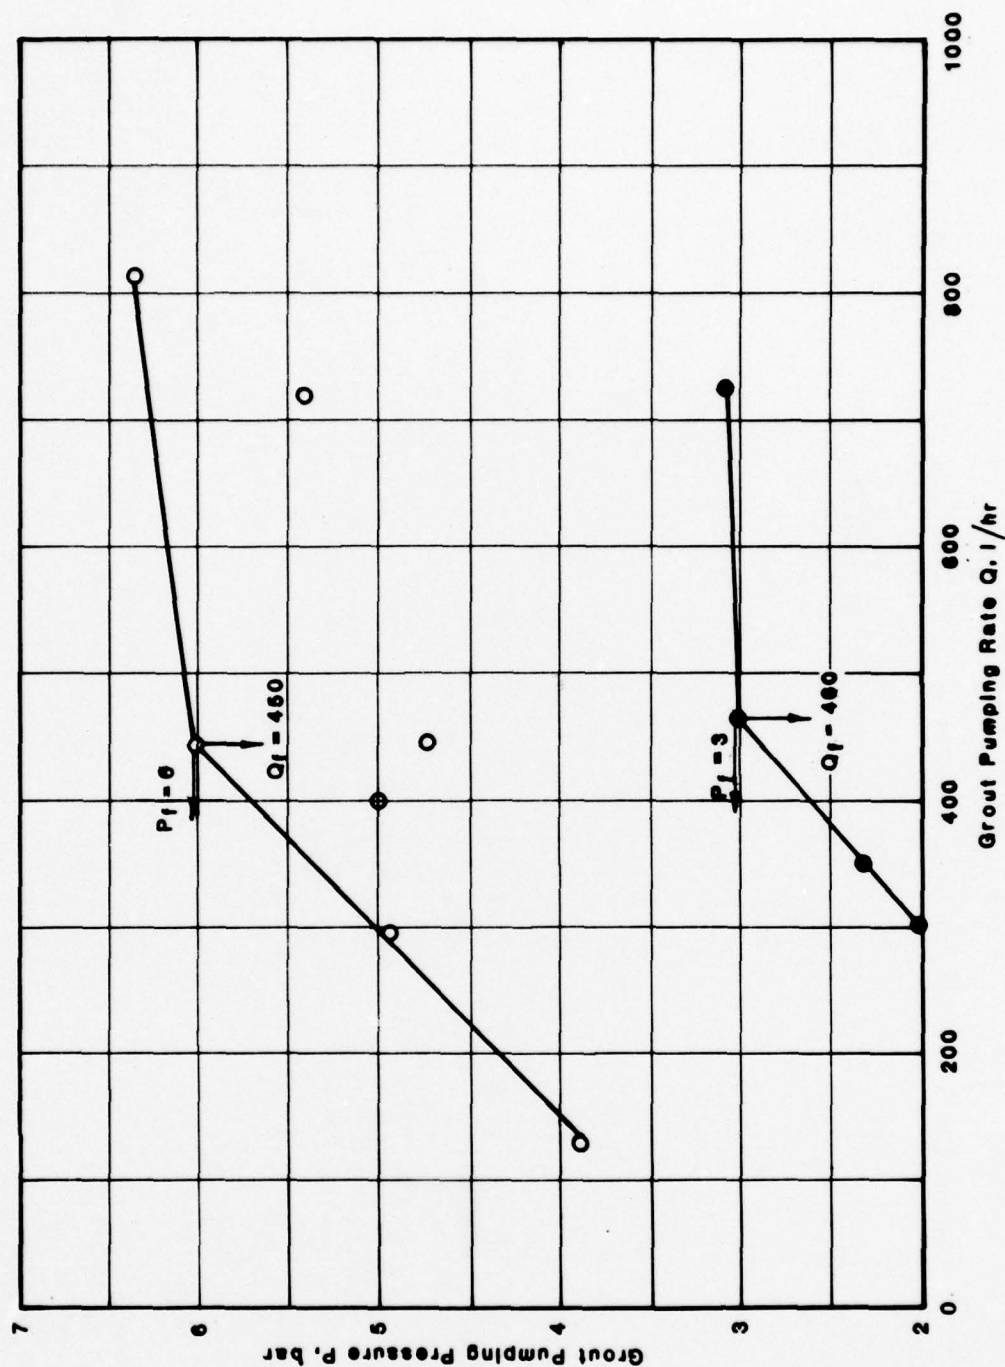
Fig 6.1

- Grout hole 10-2,
el 380 (55% Silica/Aluminate)
- Grout hole 6-1,
el 389.9
(25% Silica/Aluminate)
- Q_f = Hydraulic fracturing
grout pumping rate
- P_f = Hydraulic fracturing
grout pumping pressure

Figure 6.1	CALCULATION OF VOLUME OF GROUT TO BE INJECTED	6-5
Figure 6.2	EXAMPLE OF HYDRAULIC FRACTURING TEST RESULTS AND INTERPRETATION	6-6
